Property Inspected

Account Number 20060000XX

Inspection Report

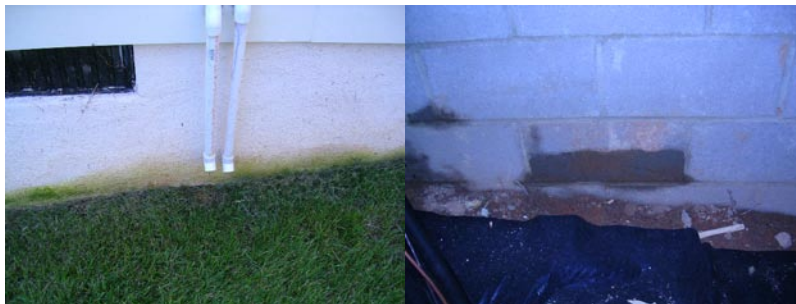
- 16.) *Describe the general structure*
The home is a wood frame two story on a block and brick foundation over a dirt crawlspace. The c-space was viewed from inside c-space via access door
- 17.) *Positive Drain*
Functional
- 19.) *Wooden Members*
Functional
- 20.) *What material is the Wooden Members*
Pre manufactured wood trusses at 24 inches o.c.
- 21.) *Support Piers*
Functional
- 22.) *What material is the Support Piers*
Brick & concrete block
- 23.) *Crawlspace Ventilation*
Functional
- 24.) *Foundation Wall*
Needs Repair
The Condensation line from the AC unit is dripping water directly onto the foundation wall. The interior foundation wall is wet. Extend the condensation line out and away from the foundation wall.

The Condensation line from the AC unit is dripping water directly onto the foundation wall. The interior foundation wall is wet. Extend the condensation line out and away from the foundation wall.

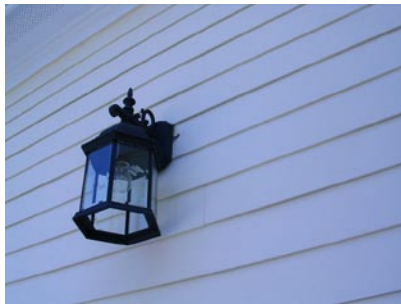
31.) *Wall Covering*

A piece of siding around the light fixture above the garage door has a hole that was filled with caulk. Replace piece of siding or fill hole with a filler that can be smoothed and painted.

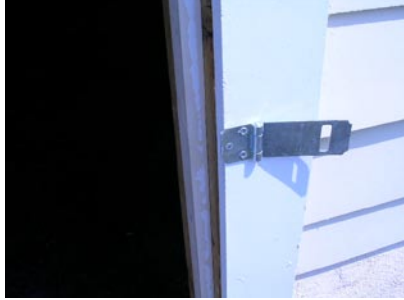
34.) *Doors*

The crawlspace door latch is hitting the door and is difficult to open and close. Adjust latch so door closes and open without hitting the latch.

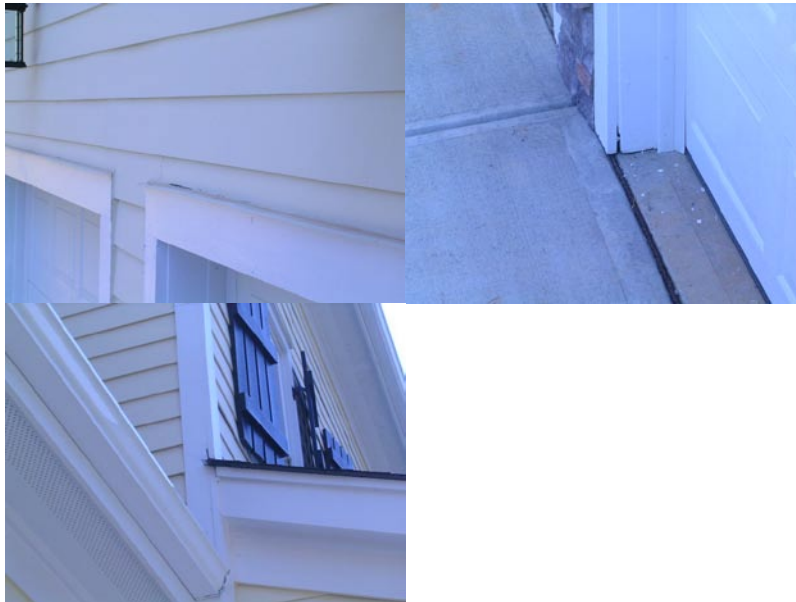
37.) *Caulking*

The trim at the bottom of the garage door needs to be caulked. The drip edge above garage door where the siding meets needs to be caulked. The trim above the left front porch needs to be caulked.

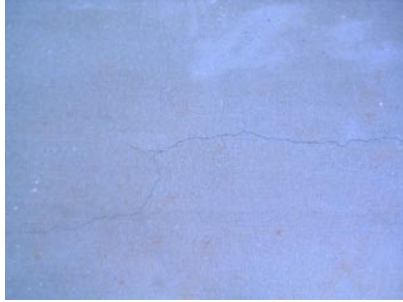
38.) *Decks and Porches*

The front porch has a crack about three feet long. This should be monitored and if the crack increases in length or width the builder should be contacted to repair. This should be pointed out to the builder now and noted so it can be reviewed at the end of the 1 year warranty

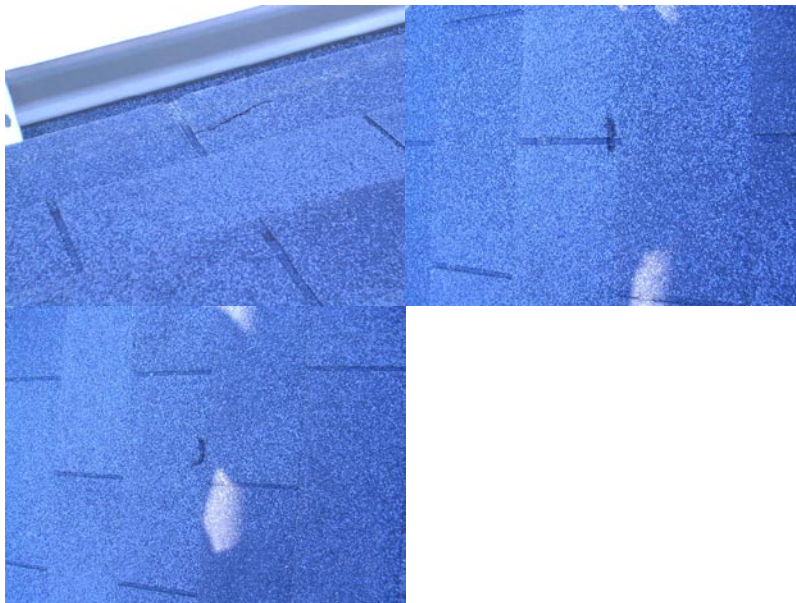
- 43.) **Are the Roof Items included in inspection**
Yes
- 44.) **Describe the roofing**
The roof is a single layer fiberglass shingle material. The roof was observed by me physically walking on it.
- 45.) **Covering Material**
Needs Repair
The shingles above the garage (first row) just above the gutter are all cracked or broken. A few shingles on the front porch have holes in them. Replace all damaged shingles as needed.

The shingles above the garage (first row) just above the gutter are all cracked or broken. A few shingles on the front porch have holes in them. Replace all damaged shingles as needed.

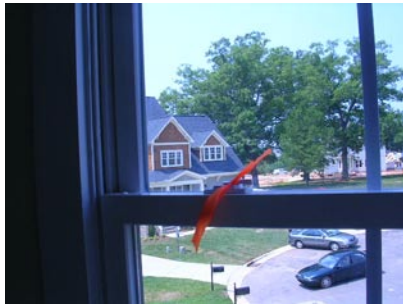
A window in the first bedroom (right bedroom at top of the stairs) is difficult to open and close. Adjust window springs to allow window to operate smoothly.

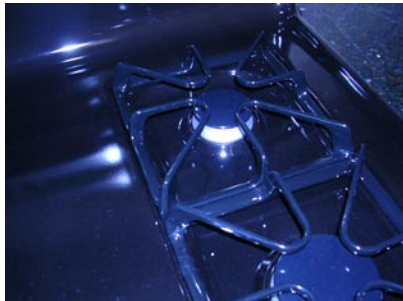
67.) *Range*

The right rear burner flame is not at full burn with in the High position. Adjust gas valve for burner as needed.

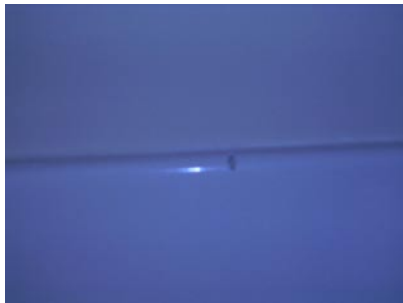
82.) *Hall Bath Tub and Shower*

The shower stall on the third floor has a large chip in the tub material. Fill with a material used to repair tub and showers.

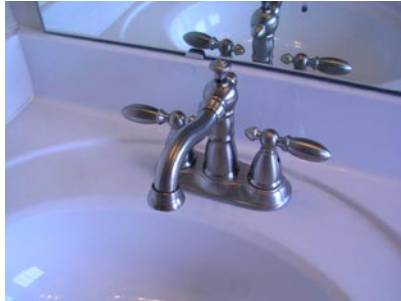
85.) *Master Bath Sink*

The left faucet is not properly secured to sink top. Adjust faucet bolts to secure to the counter top.

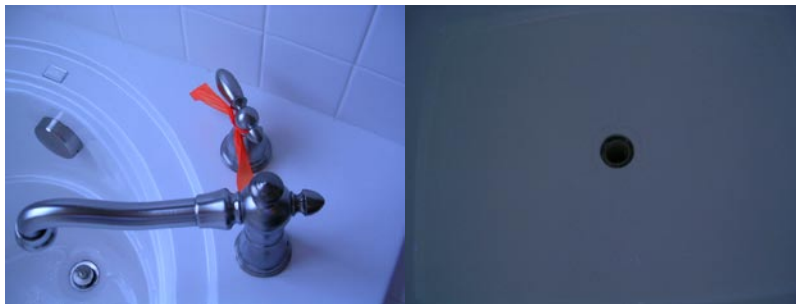
87.) *Master Bath Tub and Shower*

The hot water faucet was installed backwards. The shower is missing the floor drain cover. Re-install hot water faucet and install floor drain in the shower.

The hot water faucet has installed backwards. The shower is missing the floor drain cover. Re-install hot water faucet and install floor drain in the shower.

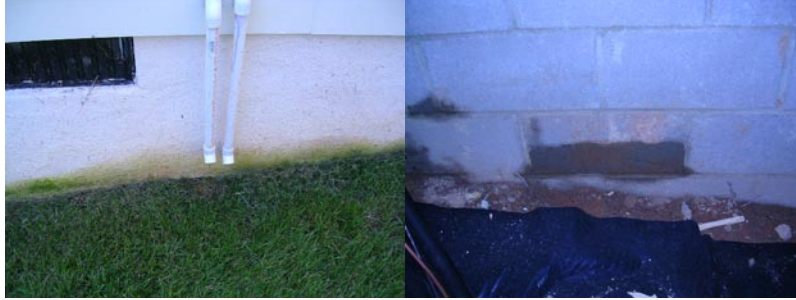
- 100.) **Is the Cooling System included in inspection**
Yes
- 101.) **Central Air Conditioner Name**
Lennox
- 102.) **Central Air Conditioner Size and Location**
Unit #1 24,000 BTU located at the right side of the house Unit #2 36,000 BTU located in the Attic.
- 103.) **Status of AC**
Functional
- 104.) **Condensate Drain Line**
Needs Repair
The Condensation line from the AC unit is dripping water directly onto the foundation wall. The interior foundation wall is wet. Extend the condensation line out and away from the foundation wall.

The Condensation line from the AC unit is dripping water directly onto the foundation wall. The interior foundation wall is wet. Extend the condensation line out and away from the foundation wall.
